Study of the causes of the collapse of a high-rise chimney under conditions of long-term operation

Abstract. This article analyzes the causes of the collapse of a high-rise chimney in Petropavlovsk. A study of the factors of long-term (over 60 years) operation of a high-altitude (H=150 m) chimney was carried out. The analysis of the constructive solution of the pipe was carried out, and the study of the operating conditions was performed. To theoretically assess the technical condition and stress-strain state factors (SSS) of the collapsed chimney, automated verification calculations were carried out based on the actual parameters and characteristics obtained during the last technical inspection. An automated verification calculation of SSS factors determining the bearing capacity of an object (its strength, rigidity, reliability, and durability) has been performed. Theoretically, the physical wear of the object has also been carried out. Based on the study of the available technical documentation and conducting a continuous, detailed instrumental examination of the facility, the expert organization established the significant causes that led to the pipe accident.

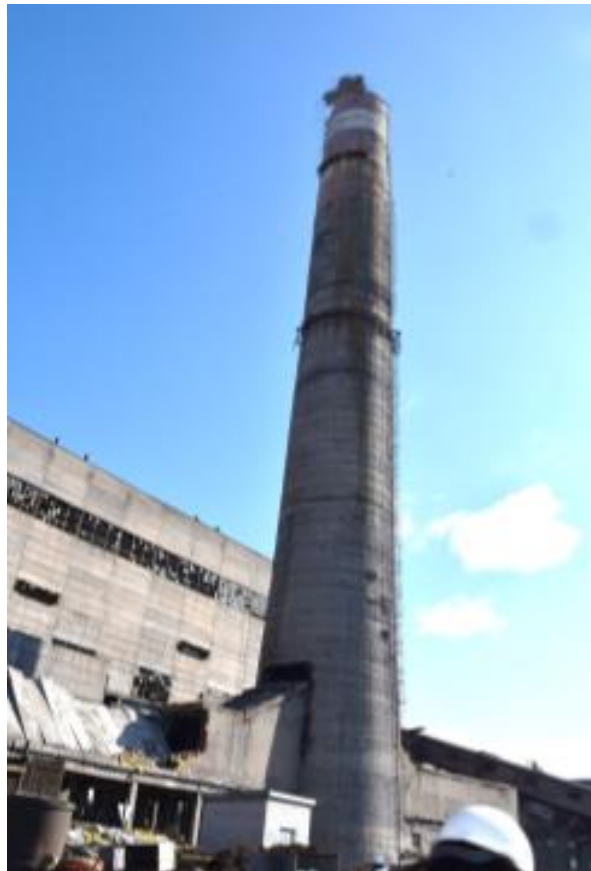
Figure 1 - General view of the chimney of Petropavlovsk TPP-2 after collapse

The preliminary conclusion (without the results of the necessary verification calculations of the stress-strain state (SSS) of the chimney structures) of the experts is as follows. Partial collapse of the chimney shaft is a consequence of several factors superimposed during the period of long-term operation: low strength of concrete of some sections of the chimney (0.50...0.83% of the design grade); violation of the integrity of the lining of its part of the length and part of the thickness of the chimney, which significantly changed the state of the temperature field of the massif of the structure due to the inhomogeneity of the conditions of heat transfer and heat transfer, which resulted in a significant increase in the values of temperature displacements and directions; increase in the moisture content of the wall of the chimney, as well as to the reduction of the design thickness in certain sections of the pipe, which created conditions for a sharp increase in mechanical stresses as a result of their spontaneous redistribution and concentration in certain sections and joints as a result of the above unfavorable factors, the presence of which created their emergency combination, which sharply reduced the level of VAT of the object led to a partial collapse of the upper part of the pipe, in which the force factor (wind load pulsation) contributed to the conditions of reduction of bearing capacity parameters.
