Main problems in the operation of metal gas discharge pipes

Abstract. This paper considers the main problems of operation of metal gas discharge pipes on the example of research and survey work on the examination of building structures of the exhaust tower with three gas discharge trunks 180 m high, flue gas purification unit of the sintering shop of LLP "NDFZ" in Zhambyl region. Analysis of the actual technical condition, considered in this article exhaust tower with three gas discharge shafts, according to the results of the survey, its volume-planning and structural solutions, showed its generally unrepairable, due to the mass of characteristic critical and unacceptable damage to the load-bearing elements of the frame, physical fatigue of materials, significant corrosion wear of metal structures, which will require a significant amount of proposed repair and maintenance work to eliminate them. The conducted complex of researches has shown that the service life of chimneys built before the 1960s and after has practically expired. Repair or reconstruction of chimneys using previously mastered technologies and materials does not solve the issues of reliability improvement. Rationa

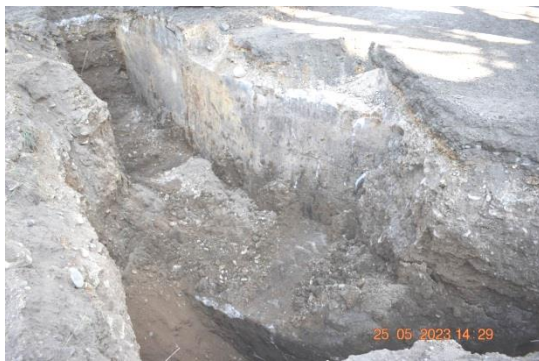
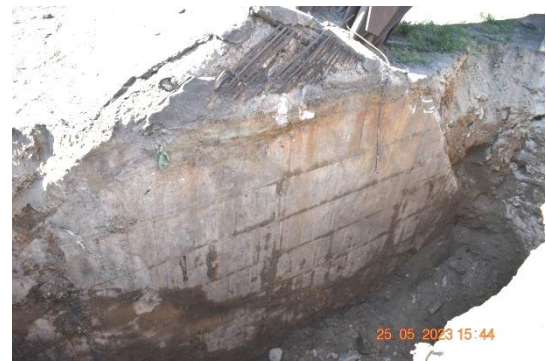
Figure 2 – General view of the opened test pits

1) inspection of the foundations in the opened pits showed that the structures were made with deviation from the geometric parameters regulated by the album of the project drawings, in particular, the foundation for the load-bearing tower is made as a continuous slab, while the project provides for a strip foundation (in the plan in the form of a ring), also, the bottom (sole) of the foundation is actually located at the level of relative elevation -3.300, but the project specifies elevation -3.500. The geometric parameters of the foundation for the tower's base struts also do not correspond to those given in the project. According to the project, the specified free-standing foundations should have been made of pyramidal shape with one vertical face without ledges with a gentle (at an acute angle) extension to the bottom, but in fact the foundation structure is made in the form of a triangle with two sloping (when viewed in profile as in the drawing) and two vertical side faces with a developed bottom part (see Figure 2).

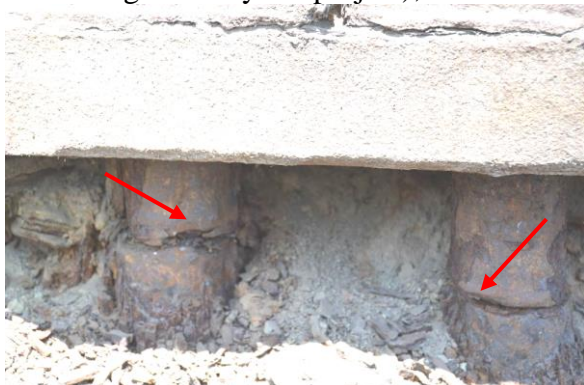
2) characteristic critical damage to the supporting foundation base of the load-bearing tower belt: the foundation bolts are broken, a rattling sound is heard when tapping - the damage was found in 3 bolts out of 12, which is 25% of the total number of bolts (see Figure 3);

Figure 3 – Breakage of foundation bolts

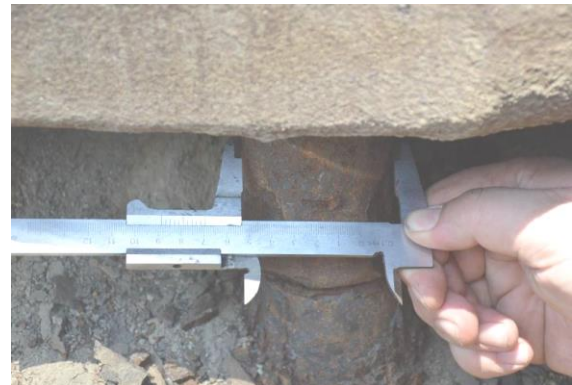
3) significant damage characteristic for all foundation bolts of the support base (see Figure 4): continuous irregular corrosion of bolts with damage of up to 14% of the area of the design cross-section, the residual diameter of bolts in localized areas of the non-threaded part is 69mm (M80 bolts are regulated by the project);

Figure 4 – Continuous irregular corrosion of foundation bolts

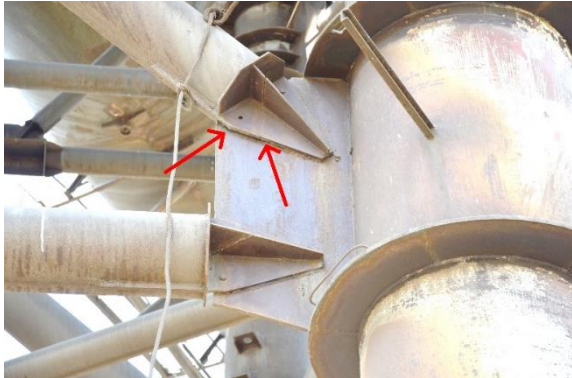
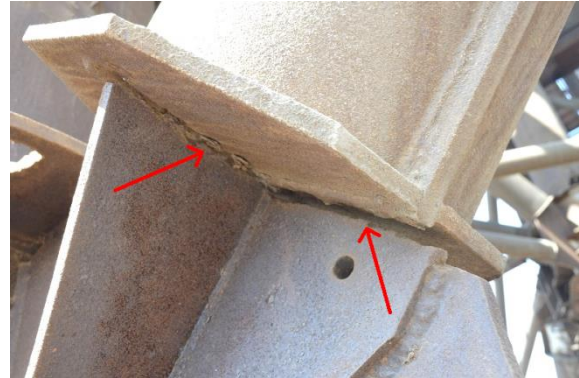
4) critical damage to all the chords of the load-bearing tower, due to the presence of characteristic closing nodes at the levels of +19,200 and +49,200, the presence of which changes the design scheme of the main load-bearing tower, thus significantly reducing its load-bearing capacity and creating conditions of unsuitability of the load-bearing tower as a whole under the action of design (project) loads (see Figure 5);

Figure 5 – Characteristic critical defect: weld rupture in the connection between the strut attachment plate and the fascia

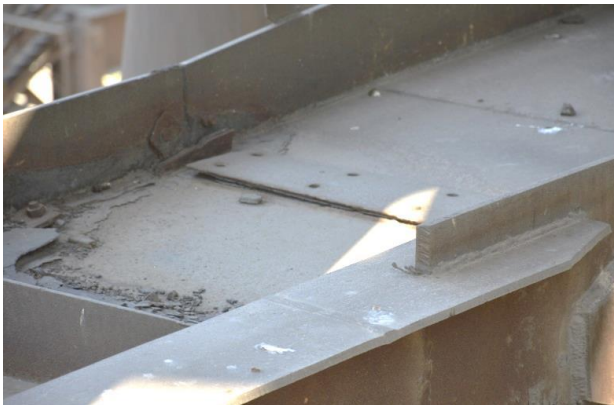
5) the presence of characteristic critical damage in the form of ruptures and cracks in the welded joints of girder strut attachment assemblies, as well as due to the presence of irregular corrosion of girder walls and flanges in the support and span sections with up to 30% of the cross-section of the elements. In addition, there are deformations of overlays (bulging), due to the development of crevice corrosion in the gaps, the size of corrosion products in some places reaches a thickness of 8 mm, indicating a significant reduction in load-bearing capacity and threatening, if no action is taken, the collapse of structures (Figure 6);

Figure 6 – Fracture of the weld along the entire length of the joint

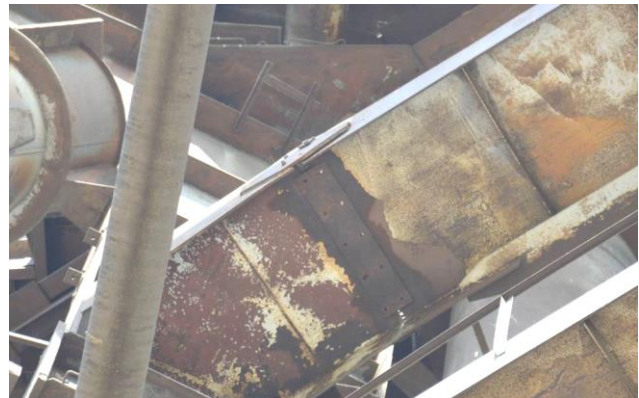
- the presence of gaps and cracks in welded joints in the nodes of fixing elements on beams and links, indicating the loss of their load-bearing capacity and threatening their collapse (Figure 7);

Figure 7 – Fracture of the weld at the fusion boundary along the entire length of the joint

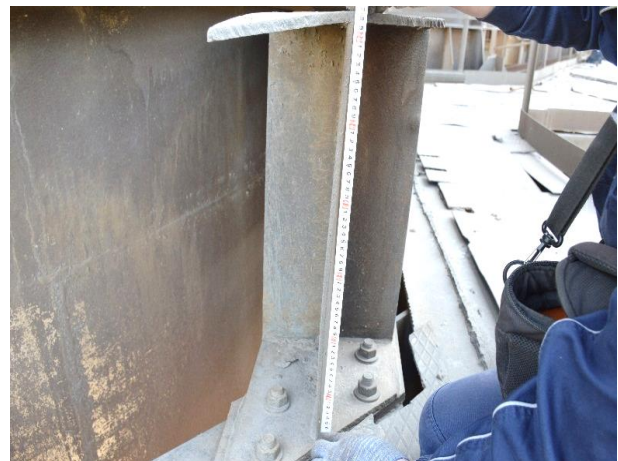
6) a set of critical defects and damages of the gas exhaust trunks No.1, No.2 and No.3, namely (Figures 8, 9):

- critical damage typical for the majority of similar connections of support beams: breaks and cracks in welded joints in the areas of support of elements; in addition, significant damage typical for the majority of similar assembly overlap welded joints of beam support assemblies: development of crevice corrosion, thickness of corrosion products is 5...10 mm;

Figure 9 – Rolls and loss of local stability of the walls of the support beams of gas outlet shafts characteristic for beams at the site level at level +49.200

Under the current conditions, in the presence of established defects and deviations of mass character in the gas-venting trunks, the development of working technical solutions to restore serviceability, including strengthening and replacement of individual structures, followed by their qualitative implementation was inexpedient. In this regard, KazMIRR Institute gave recommendations for the complete replacement of gas exhaust shafts No. 1, 2 and 3, including their supporting elements.
