## Main problems in the operation of metal gas discharge pipes

**Abstract.** This paper considers the main problems of operation of metal gas discharge pipes on the example of research and survey work on the examination of building structures of the exhaust tower with three gas discharge trunks 180 m high, flue gas purification unit of the sintering shop of LLP "NDFZ" in Zhambyl region. Analysis of the actual technical condition, considered in this article exhaust tower with three gas discharge shafts, according to the results of the survey, its volume-planning and structural solutions, showed its generally unrepairable, due to the mass of characteristic critical and unacceptable damage to the load-bearing elements of the frame, physical fatigue of materials, significant corrosion wear of metal structures, which will require a significant amount of proposed repair and maintenance work to eliminate them. The conducted complex of researches has shown that the service life of chimneys built before the 1960s and after has practically expired. Repair or reconstruction of chimneys using previously mastered technologies and materials does not solve the issues of reliability improvement.

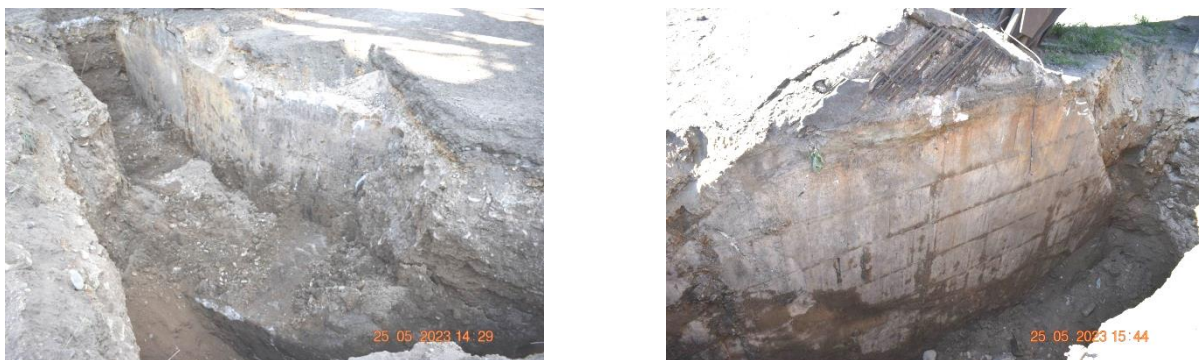
1) inspection of the foundations in the opened pits showed that the structures were made with deviation from the geometric parameters regulated by the album of the project drawings, in particular, the foundation for the load-bearing tower is made as a continuous slab, while the project provides for a strip foundation (in the plan in the form of a ring), also, the bottom (sole) of the foundation is actually located at the level of relative elevation -3.300, but the project specifies elevation -3.500. The geometric parameters of the foundation for the tower's base struts also do not correspond to those given in the project. According to the project, the specified free-standing foundations should have been made of pyramidal shape with one vertical face without ledges with a gentle (at an acute angle) extension to the bottom, but in fact the foundation structure is made in the form of a triangle with two sloping (when viewed in profile as in the drawing) and two vertical side faces with a developed bottom part (see Figure 2).

Figure 2 – General view of the opened test pits

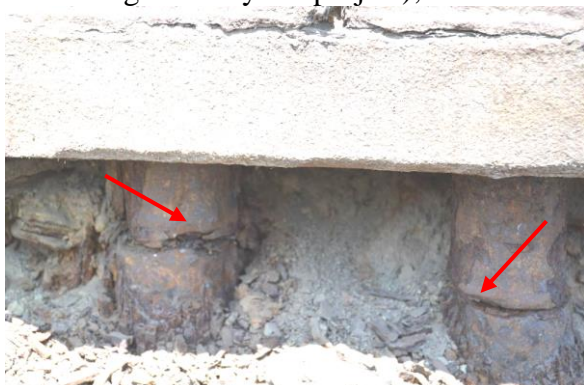
2) characteristic critical damage to the supporting foundation base of the load-bearing tower belt: the foundation bolts are broken, a rattling sound is heard when tapping - the damage was found in 3 bolts out of 12, which is 25% of the total number of bolts (see Figure 3);

Figure 3 – Breakage of foundation bolts

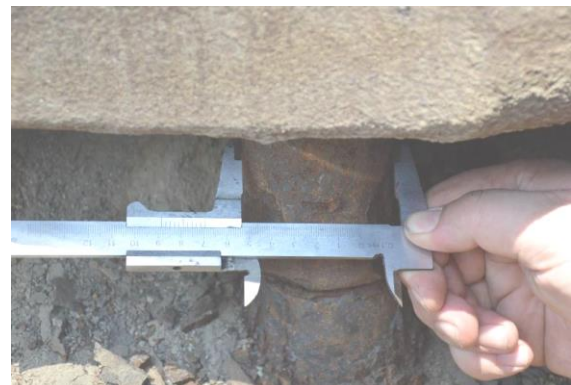
3) significant damage characteristic for all foundation bolts of the support base (see Figure 4): continuous irregular corrosion of bolts with damage of up to 14% of the area of the design cross-section, the residual diameter of bolts in localized areas of the non-threaded part is 69mm (M80 bolts are regulated by the project);

Figure 4 – Continuous irregular corrosion of foundation bolts

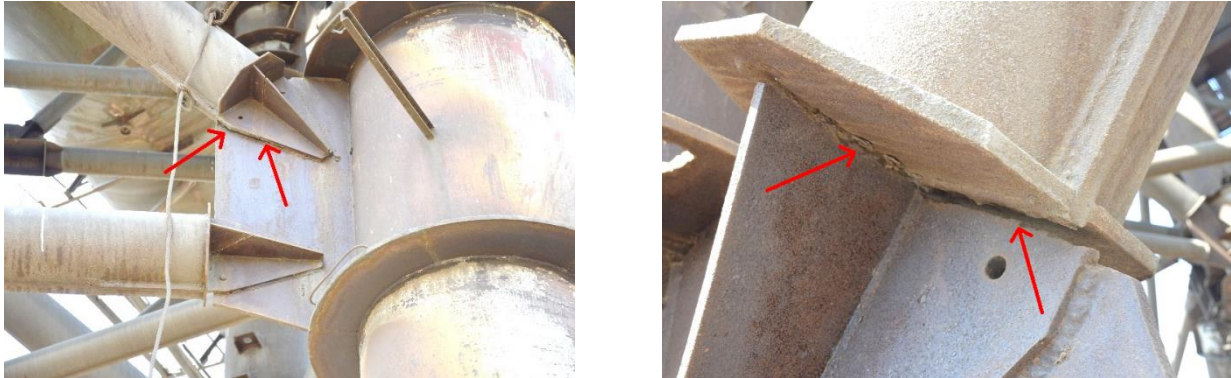
4) critical damage to all the chords of the load-bearing tower, due to the presence of characteristic closing nodes at the levels of +19,200 and +49,200, the presence of which changes the design scheme of the main load-bearing tower, thus significantly reducing its load-bearing capacity and creating conditions of unsuitability of the load-bearing tower as a whole under the action of design (project) loads (see Figure 5);

Figure 5 – Characteristic critical defect: weld rupture in the connection between the strut attachment plate and the fascia

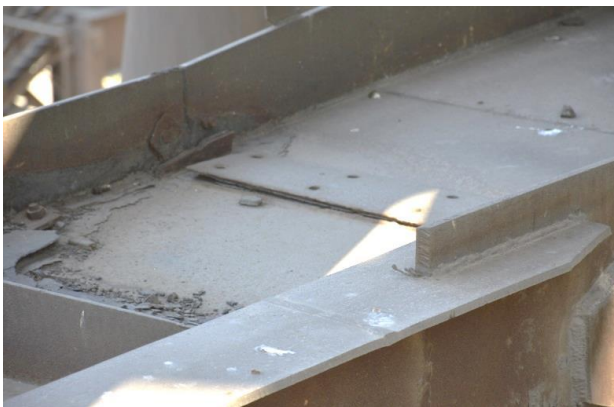
5) the presence of characteristic critical damage in the form of ruptures and cracks in the welded joints of girder strut attachment assemblies, as well as due to the presence of irregular corrosion of girder walls and flanges in the support and span sections with up to 30% of the cross-section of the elements, In addition, there are deformations of overlays (bulging), due to the development of crevice corrosion in the gaps, the size of corrosion products in some places reaches a thickness of 8 mm, indicating a significant reduction in load-bearing capacity and threatening, if no action is taken, the collapse of structures (Figure 6);

Figure 6 – Fracture of the weld along the entire length of the joint

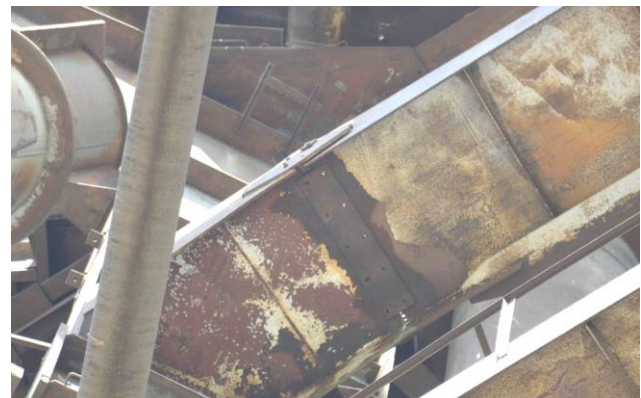
- the presence of gaps and cracks in welded joints in the nodes of fixing elements on beams and links, indicating the loss of their load-bearing capacity and threatening their collapse (Figure 7);

Figure 7 – Fracture of the weld at the fusion boundary along the entire length of the joint

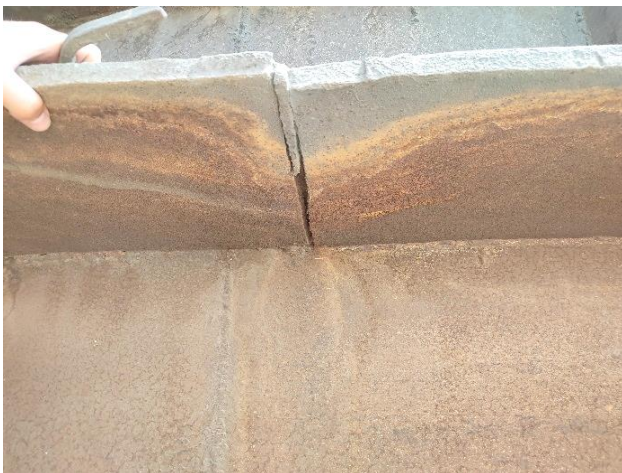
6) a set of critical defects and damages of the gas exhaust trunks No.1, No.2 and No.3, namely (Figures 8, 9):

- deviations from the original design in terms of reduction of the thickness of the shell sheets and trunk support rings in comparison with the original design;
- deviations from the design in the form of non-compliance of the support units of trunk support beams;
- ruptures of shaft shells in the places where the support ring ribs meet;

- cracks along the entire length of the butt-welded joints of the butt-welded assembly of the support ring ribs, as well as the ring support ribs are welded to the barrel shell with a one-sided weld; butt welded joints of the ring ribs are made with incomplete welds, there are also metal inclusions in the joints;

Figure 8 – Support ring of gas outlet shaft No.1 at the level of site level at level +49.200

Under the current conditions, in the presence of established defects and deviations of mass character in the gas-venting trunks, the development of working technical solutions to restore serviceability, including strengthening and replacement of individual structures, followed by their qualitative implementation was inexpedient. In this regard, KazMIRR Institute gave recommendations for the complete replacement of gas exhaust shafts No. 1, 2 and 3, including their supporting elements.

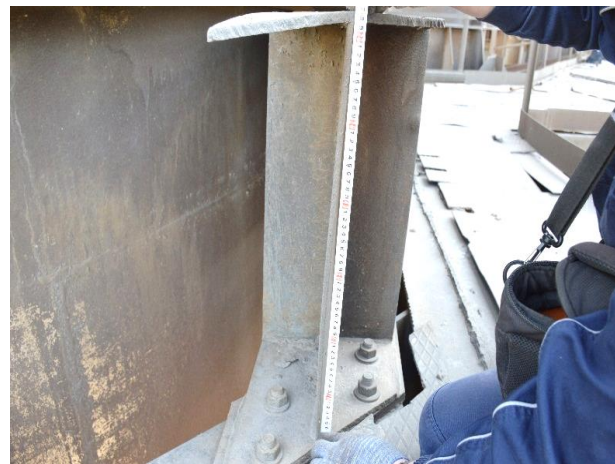
- critical damage typical for the majority of similar connections of support beams: breaks and cracks in welded joints in the areas of support of elements; in addition, significant damage typical for the majority of similar assembly overlap welded joints of beam support assemblies: development of crevice corrosion, thickness of corrosion products is 5...10 mm;

- critical damage typical for all elements of sliding supports: ruptures of welded joints of guide angles with the beam, ruptures of welded joints of support plates of sliding element (channels) with ring ribs; in addition, development of crevice corrosion between contact surfaces of elements, thickness of corrosion products reaches 30 mm;

Figure 9 – Rolls and loss of local stability of the walls of the support beams of gas outlet shafts characteristic for beams at the site level at level +49.200
