## Study of the causes of the collapse of a high-rise chimney under conditions of long-term operation

**Abstract.** This article analyzes the causes of the collapse of a high-rise chimney in Petropavlovsk. A study of the factors of long-term (over 60 years) operation of a high-altitude (H=150 m) chimney was carried out. The analysis of the constructive solution of the pipe was carried out, and the study of the operating conditions was performed. To theoretically assess the technical condition and stress-strain state factors (SSS) of the collapsed chimney, automated verification calculations were carried out based on the actual parameters and characteristics obtained during the last technical inspection. An automated verification calculation of SSS factors determining the bearing capacity of an object (its strength, rigidity, reliability, and durability) has been performed. Theoretically, the physical wear of the object has also been carried out. Based on the study of the available technical documentation and conducting a continuous, detailed instrumental examination of the facility, the expert organization established the significant causes that led to the pipe accident.

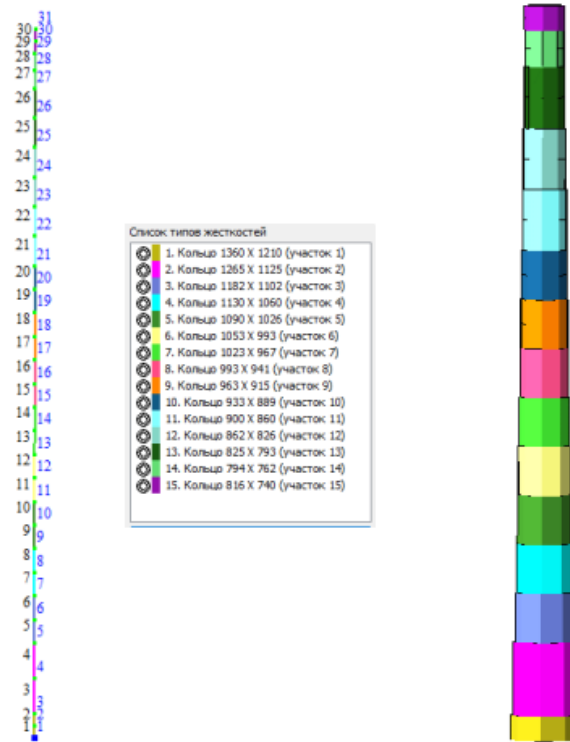
Figure 2 – Calculation diagram of the chimney

To theoretically assess the technical condition and VAT factors of the collapsed chimney, automated verification calculations were carried out according to the actual parameters and characteristics obtained during the last technical inspection, and the following results were obtained (Figure 2):

- 1.4 times underestimated the actual wind load, for which, for its time, this chimney was designed;
- the load-bearing capacity of the shaft on the first turbine of limit states, on which design sections are not provided (there is an excess of design resistance of concrete to compression);
- since the lining on the 10th section (in the area of +25.0m) is significantly disturbed (according to the results of the last inspection), the chimney shaft is in direct contact with flue gases, as a result of which the total stress from the force and temperature load amounted to 5.79MPa, which exceeds the design resistance of concrete in 5.1MPa (the increase in the total stress is due to the growth of temperature stress from 1.33MPa to 3.4MPa).

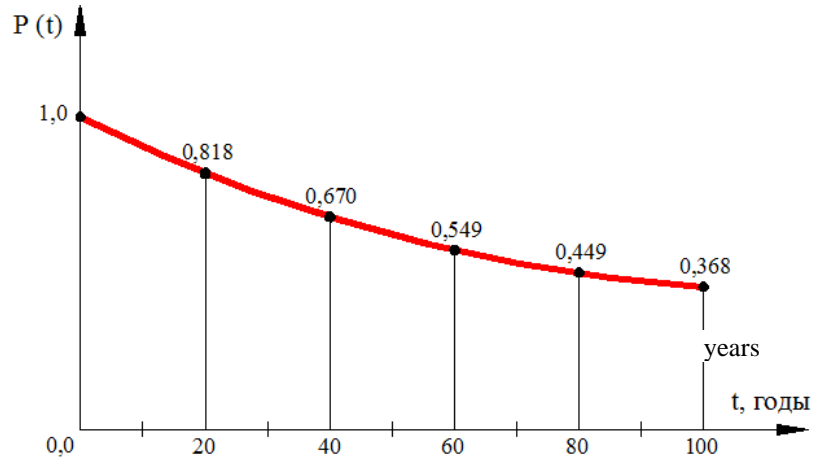
Figure 3 – Dependence of the "FFO" value on the parameter "t"

If we consider that the probability of failure-free operation (FFO) less than 67% is unacceptable from the point of view of reliability of further operation, then according to the graph in Fig. 1, the suitable service life of this chimney should not exceed 40 years. The actual service life of the chimney at the moment of the last technical inspection was more than 61 years, i.e., according to our research, the operation of the collapsed chimney should have been suspended more than 20 years ago.
