Rehabilitation of lengthy sewer pipelines by polymer-composite CIPP

Abstract. This study examines the feasibility of Cured-in-Place Pipe (CIPP) technology for trenchless rehabilitation of aging sewer pipelines, addressing the severe deterioration of Karaganda's sewer networks. A 3 km section was inspected using CCTV, ultrasonic, and shock-pulse methods to assess pipeline conditions, revealing structural defects with depreciation levels reaching 70-100%. The CIPP method was successfully applied to restore the integrity of 2.6 km pipelines while minimizing excavation, stabilizing the average flow rates and velocity of 0.8-1.2 m pipelines at 710 liter/s and 1.2 m/s, respectively. Hydraulic analysis confirmed that rehabilitated pipelines maintained sufficient flow velocity for self-cleaning and increased capacity, reducing blockage risks. The findings demonstrate that CIPP is a sustainable alternative to pipeline replacement, offering a viable solution for long-length sewer rehabilitation and supporting strategic urban infrastructure renewal.

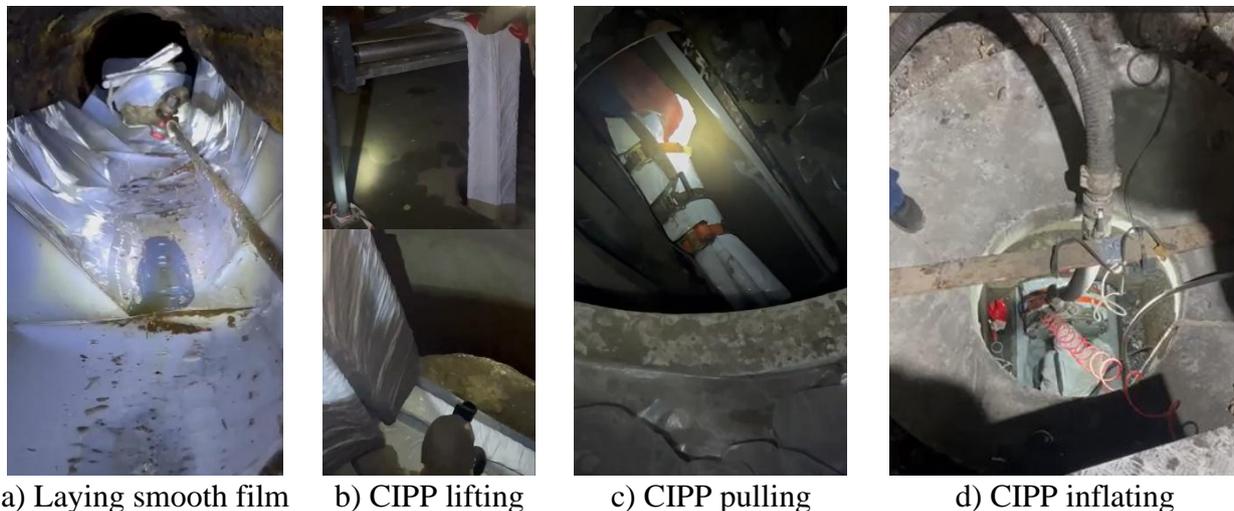
Figure 1 – Installation of polymer-composite CIPPs

Each CIPP was lifted through the manholes (Figure 1b) and pulled through the pipe to the next manhole using a winch (Figure 1c). A smooth film was pre-laid to protect the CIPP against damages (Figure 1a). The molding of CIPPs was conducted pneumatically (Figure 1d). The epoxy resin adhesive was used to bond CIPPs with existing pipes. Curing of the adhesive was carried out utilizing ultraviolet emission [20]. The hydraulic calculation of newly erected CIPPs were carried out according to [21].

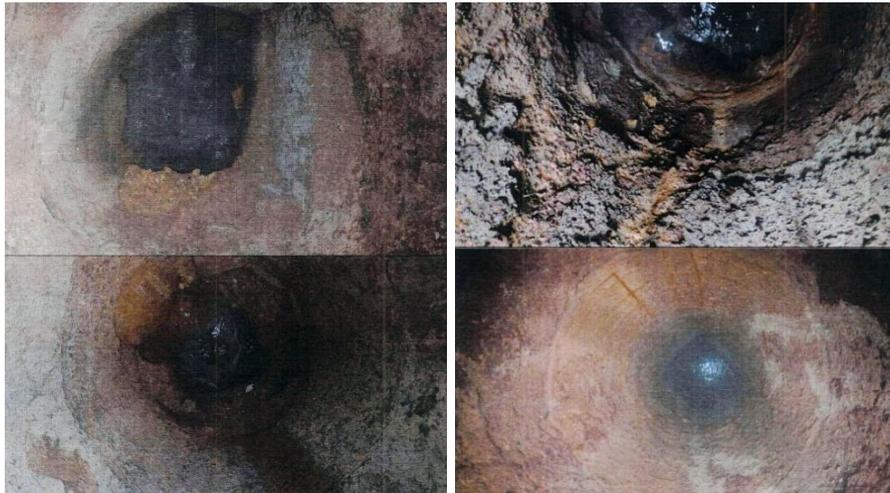
Figure 2 – Pipelines condition before CIPP installation

As shown in Figure 4 above, the CCTV revealed and recorded distinct defects and debris in pipelines, which indicate their extensive deterioration, reduction in sewage flow rate, and expectance of failure. These issues include the cracking, splitting, and corrosion of pipe material, damage of reinforcement up to 70%, displacement of joints leading to groundwater infiltration, presence of silt and stagnations, coarse household wastes, and stones. The study revealed that the degree of depreciation of sections No. 1-3 of pipelines amounted to 70%. Section No. 4 of the pipelines encountered the worst damage with a deprecation degree of 100% indicating its unserviceability leading to soon subsidence of land above. Therefore, for this section, a decision was made to replace the pipes by excavation, which overcomes the [8] and [10] omissions.

The instrumental inspection by ultrasonic and shock-pulse methods revealed that the reinforced concrete elements of inspected pipes correspond to the strength class of B7.5. This indicates a fourfold loss of strength since it is supposed to be the class of B30 according to [22].

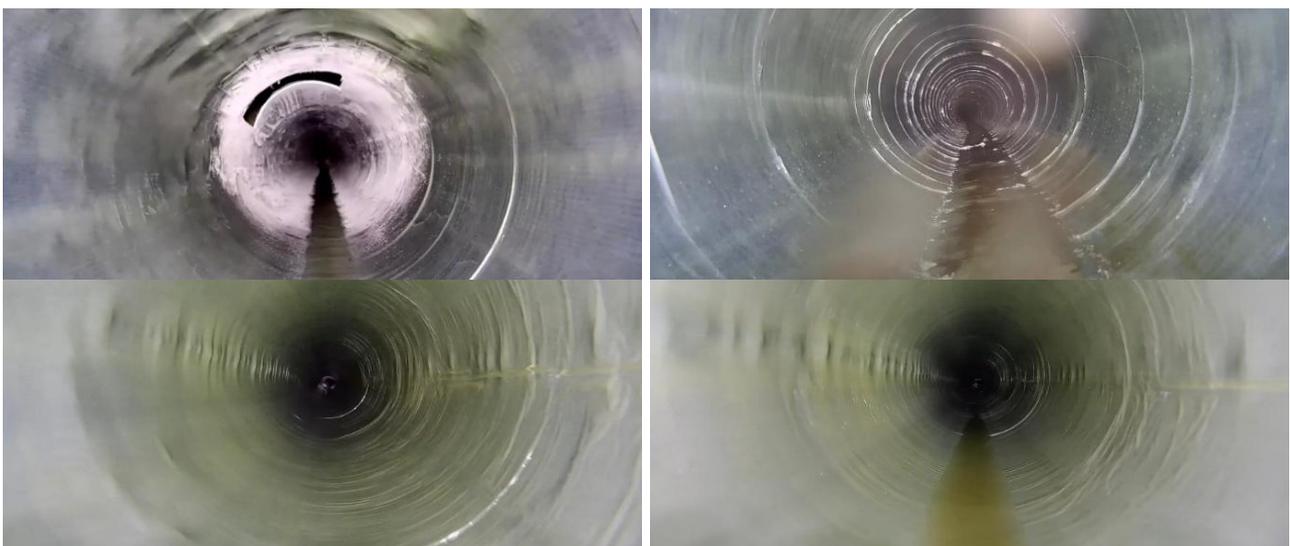
Figure 3 – Pipelines condition after CIPP installation

Figure 3 above clearly demonstrates how much the pipes were transformed after the cleaning, washing, and installation of CIPPs. It is possible to observe an increase in diameter, and consequently

stabilization of sewage flow. The post-installation CCTV images clearly show a significant improvement in the structural condition of the pipelines. The previously observed cracks, joint misalignments, and obstructions were eliminated after the cleaning and CIPP installation. The increase in pipeline smoothness is expected to enhance sewage flow and reduce the likelihood of further debris accumulation.
