Defects in a dilapidated building resulting in loss of bearing capacity of supporting structures

Alizhan Kazkeyev^{1,*}, Daniyar Kenzhebekov², Nursultan Tattikulov²

"Amangeldy comprehensive school" in Karaganda region, Kazakhstan. The design and construction of the school began in 2003, and the school opened to students in 2007. Inspections at the site were carried out in 2017 and 2022. The peculiarity of this case is that the school building was in a mothballed state from the start of construction until it was put into operation. In this example, we can clearly assess the impact of natural factors on the integrity of the building when no measures are taken to maintain the current condition of the building. The most recent survey revealed the building to be unsuitable for further operation for a number of reasons [5]. This article examines the features of the load-bearing structures of the school building that are subject to significant damage and are on the verge of collapse (foundation, walls, floors, and coverings).

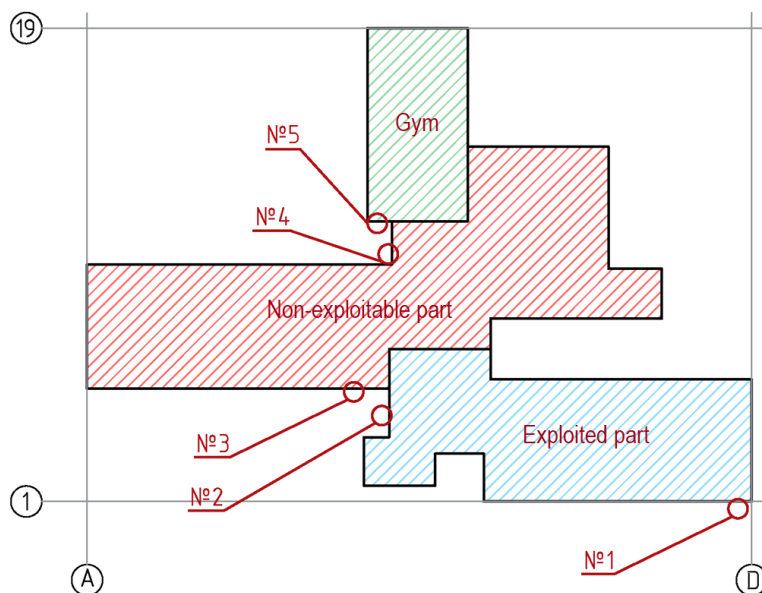
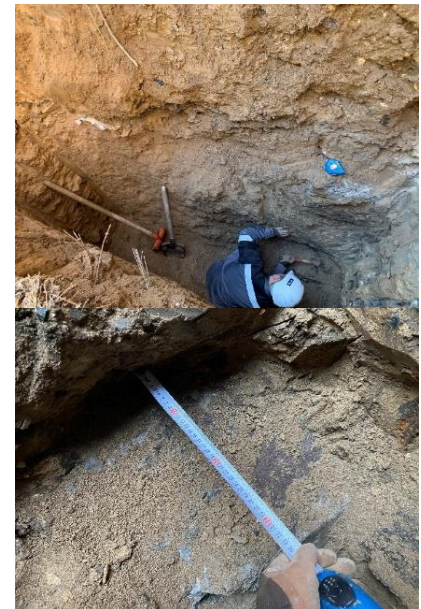
Figure 1 – Pits layout

Pits were made at 5 points (Figure 1) in order to inspect the condition of the foundations, to determine their depth and to check their strength.

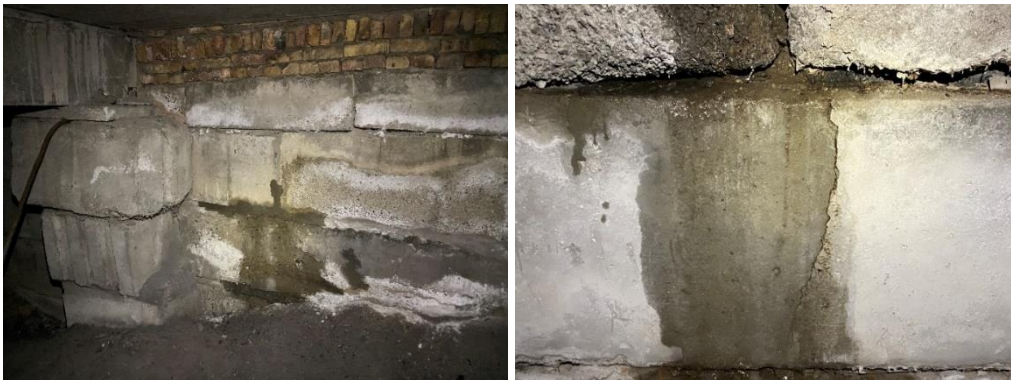
preparation. According to the results of pits, the depth of foundation from ground level is from 2.95 m to 3.25 m, depending on the absolute ground level mark. At the time of visual and instrumental inspection of the building's foundation, there were ubiquitous traces of efflorescence on the walls of the foundation blocks, local shrinkage cracks in the body of the foundation blocks (Figure 2).

Figure 2 – Efflorescence (left) and shrinkage cracks (right) of foundation

Shock-pulse tests revealed concrete strength values of foundation blocks from 33.9 to 40.3 MPa, with an average of 37.8 MPa.

The overall technical condition of the foundation is satisfactory. The category of assessment of the technical condition of the foundation is Category II (serviceable structure). According to [5] and the identified defects, the physical deterioration of the foundation is 39%. These figures are atypical for a building less than 20 years old, but it is worth bearing in mind that the building was exposed to a hostile environment prior to commissioning. For example, the degree of physical deterioration for buildings less than 20 years old is usually about 10% with proper maintenance [7].

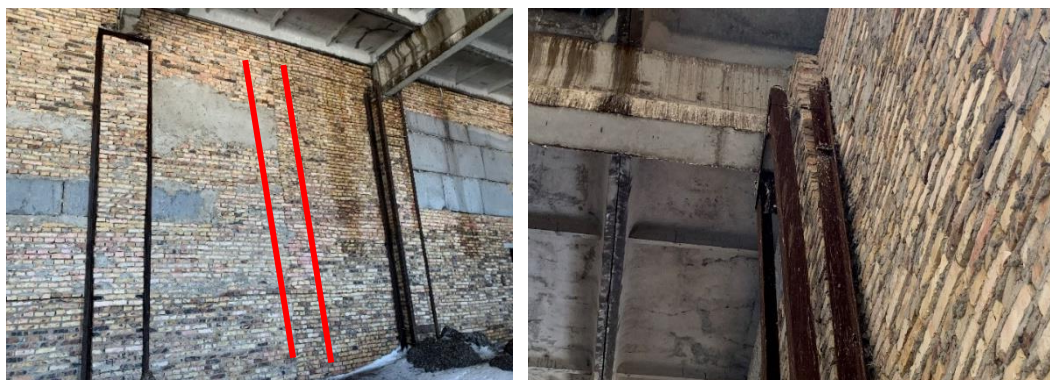
The walls of the main part of the building are made of large expanded clay concrete blocks with a thickness of 570 mm. The walls of the gymnasium are made of 380 mm thick brickwork and 120 mm thick cladding. The technical inspection revealed that the walls of part of the gymnasium were re-built from brickwork. The brickwork of the walls of the gymnasium was not performed with high quality, there were no reinforcing belts, the new masonry was not bound to the old masonry, and vertical deviations were visually observed. During construction and installation works of the walls of the gymnasium concrete blocks of different sizes were partially used instead of bricks, which had an adverse effect on the wall structure in the form of uneven load. For this reason, cracks occurred in the wall body (Figure 3, left). To mount the reinforced concrete beams, brick columns were made in the body of the gymnasium's load-bearing walls 630 mm wide. The brick columns were reinforced with metal casing made of angles, but the reinforcement structures are not of good quality and do not ensure their performance (Figure 3, right).

Figure 3 – Weak bonding (left) and poor strengthening (right) of masonry

According to the geodetic surveys of the gymnasium walls, the average value of vertical deviation from the plane was 80-90 mm, and the maximum deviation was 147 mm. While the allowable deviation per floor is 10 mm according to [5]. The inspection of the wall blocks in the unexploited part of the building revealed that under the influence of natural conditions there was a gradual destruction and delamination of the wall blocks. At the time of the visual and instrumental examination of the building walls a number of defects were revealed. Schemes of their location are shown in Figure 4 below.

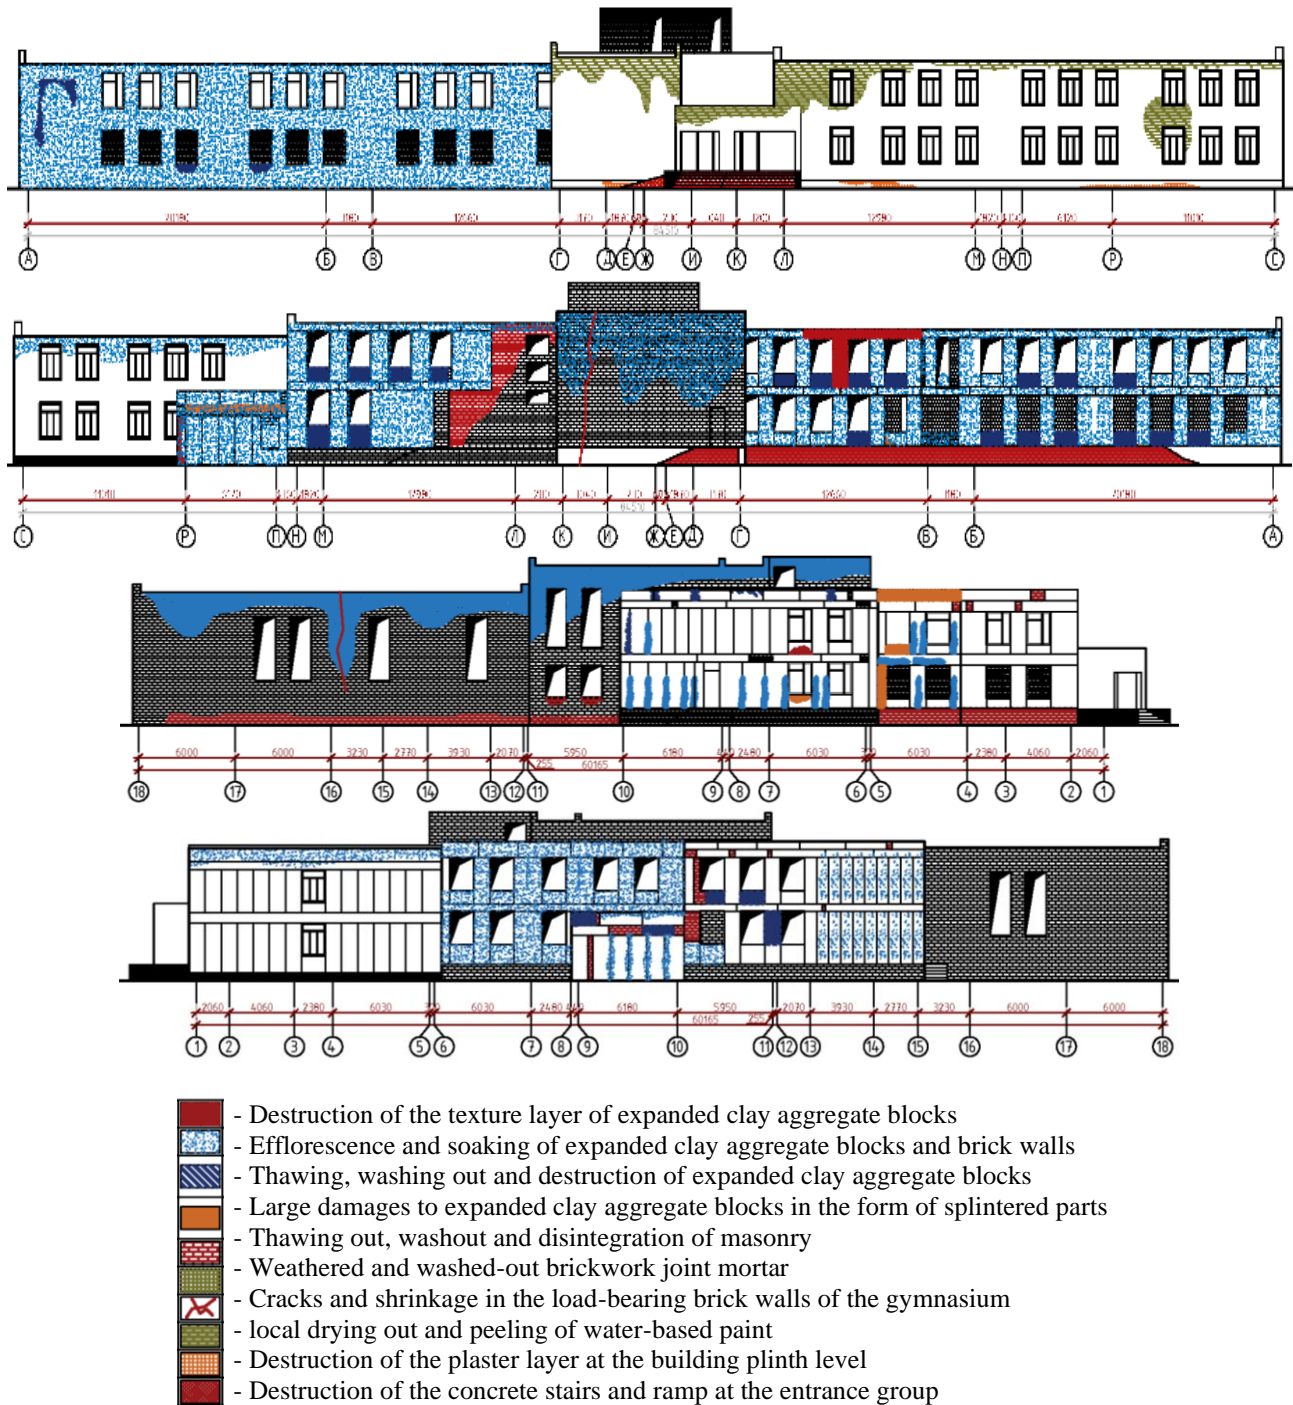
Figure 4 – Defects of walls

General technical condition of the walls - unsatisfactory. Evaluation category of the technical condition of the walls - Category IV (pre-emergency condition of the structure). According to [5] and the defects detected, the physical deterioration of the walls is 65%.

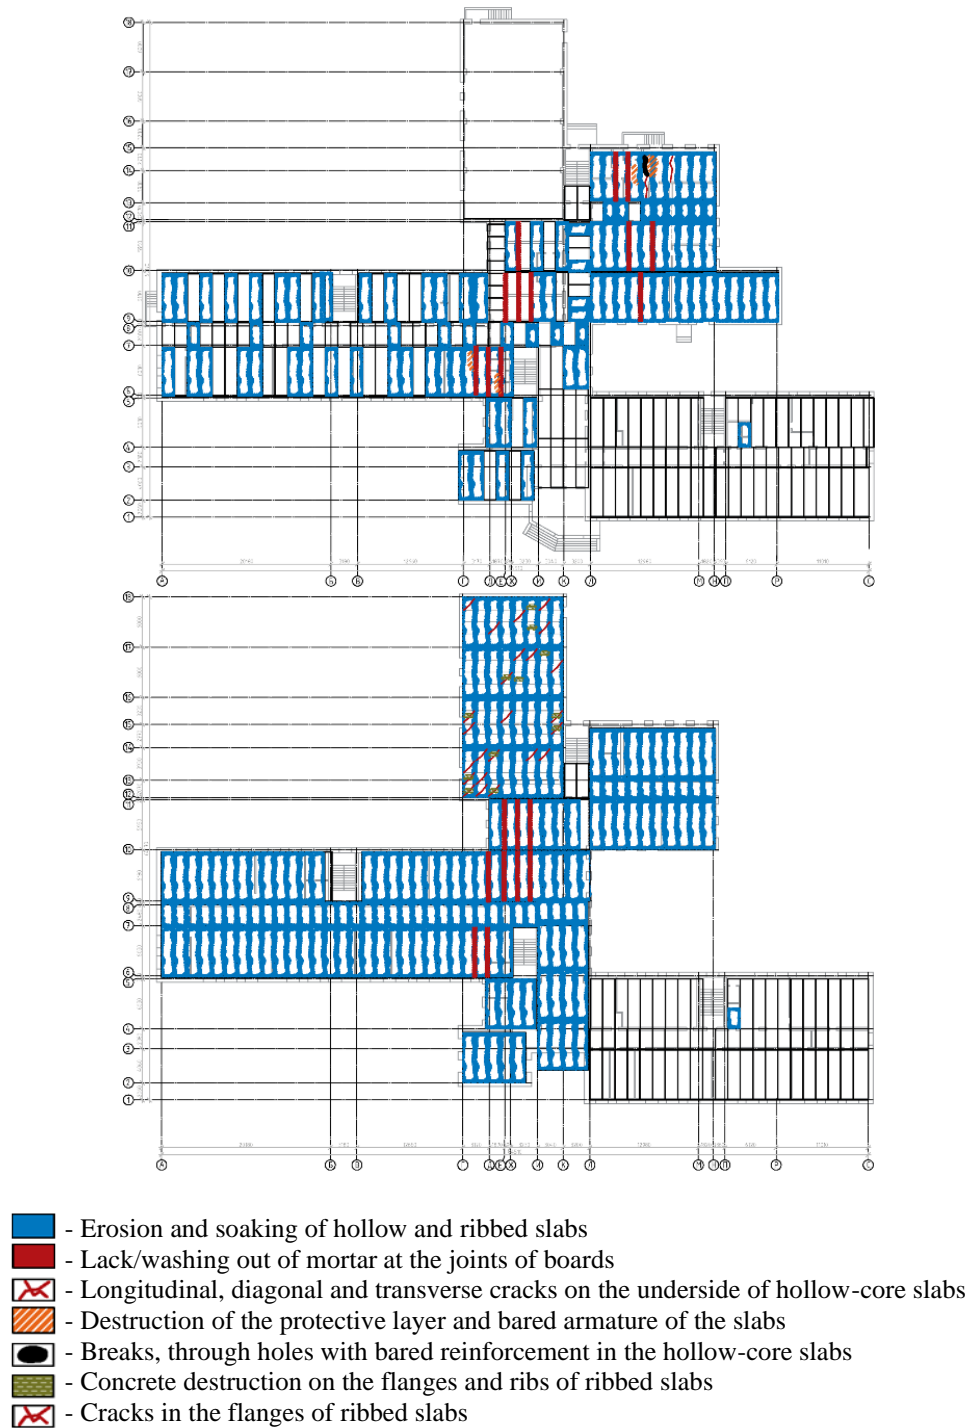
Figure 5 – Defects of floor and cover slabs

Cracks in the longitudinal, transverse ribs and slab flange occurred as a result of soaking of the slabs due to leaking roofing and environmental exposure. Corrosion of the reinforcement is usually observed in places with low density and insufficient thickness of the protective layer of

concrete. The corrosion products of the reinforcement, having a greater volume, have a spreading action and gradually destroy the concrete of the protective layer, leading to the formation of cracks. Through these cracks the moisture comes most intensively, accelerating the process of corrosion of the reinforcement and increasing the width of the crack opening. Subsequently, these processes lead to crumbling of the concrete protective layer, bare reinforcement and its intense corrosion.

According to the geodetic survey of the gymnasium floor slabs, the average deflection of the slabs is 18-20 mm, the maximum deflection is 29 mm. The allowable value of the deflection of the plates is 30 mm. Tests by shock impulse method revealed concrete strength values of foundation blocks from 26.8 to 31.9 MPa, with an average of 29.4 MPa.

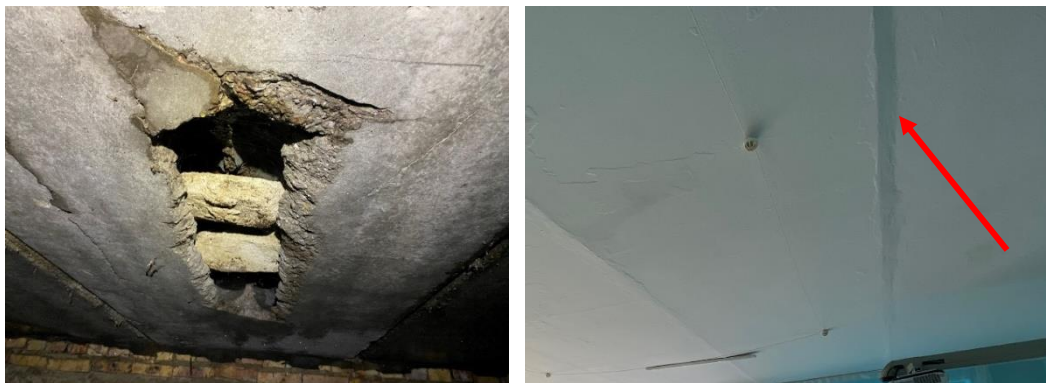
Also, at the time of visual and instrumental inspection, an emergency section of the basement floor slab under the gymnasium was revealed - an area of a broken multi-hollow slab (Figure 6, left). Also areas of the slabs with unacceptable deflection and diagonal cracks were revealed. These floor slabs cannot be restored. In the classrooms in the operational part of the building, there is a displacement of up to 50 mm from the vertical of the slabs (Figure 6, right).

Figure 6 – Breaks (left) and displacement (right) of slabs

The general technical condition of the floor and roof slabs is unsatisfactory. Evaluation category of the technical condition of the floor slabs - Category III (limited serviceability of the structure). According to [5] and the defects detected, the physical deterioration of the floor and cover slabs is 55%.
