Technobius

Volume 6, No. 2, 2026

Special Issue on Advances in Civil Engineering Materials and Structures

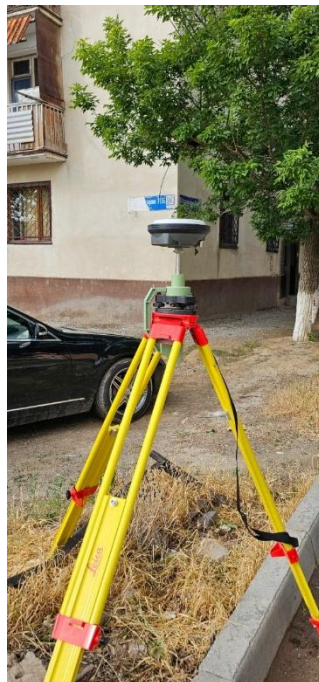
Figure 3 – Temporary GNSS benchmark

Figure 3 illustrates a typical temporary GNSS benchmark used for network referencing.

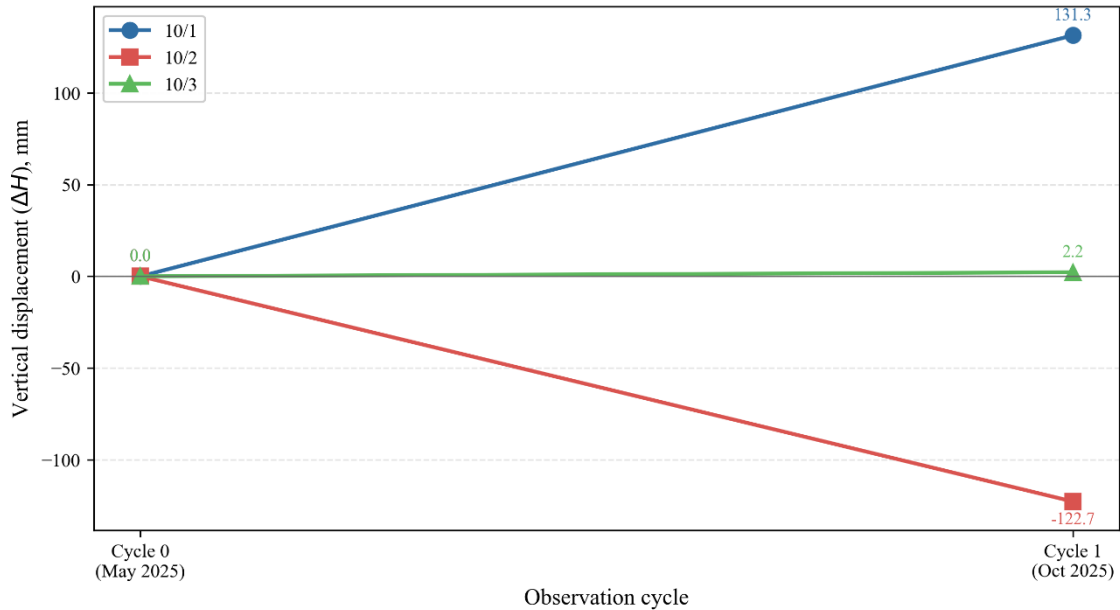
Figure 7 – Temporal development of vertical displacement at deformation marker 10

Figure 7 presents the temporal evolution of elevation changes for the three markers between May and October 2025.

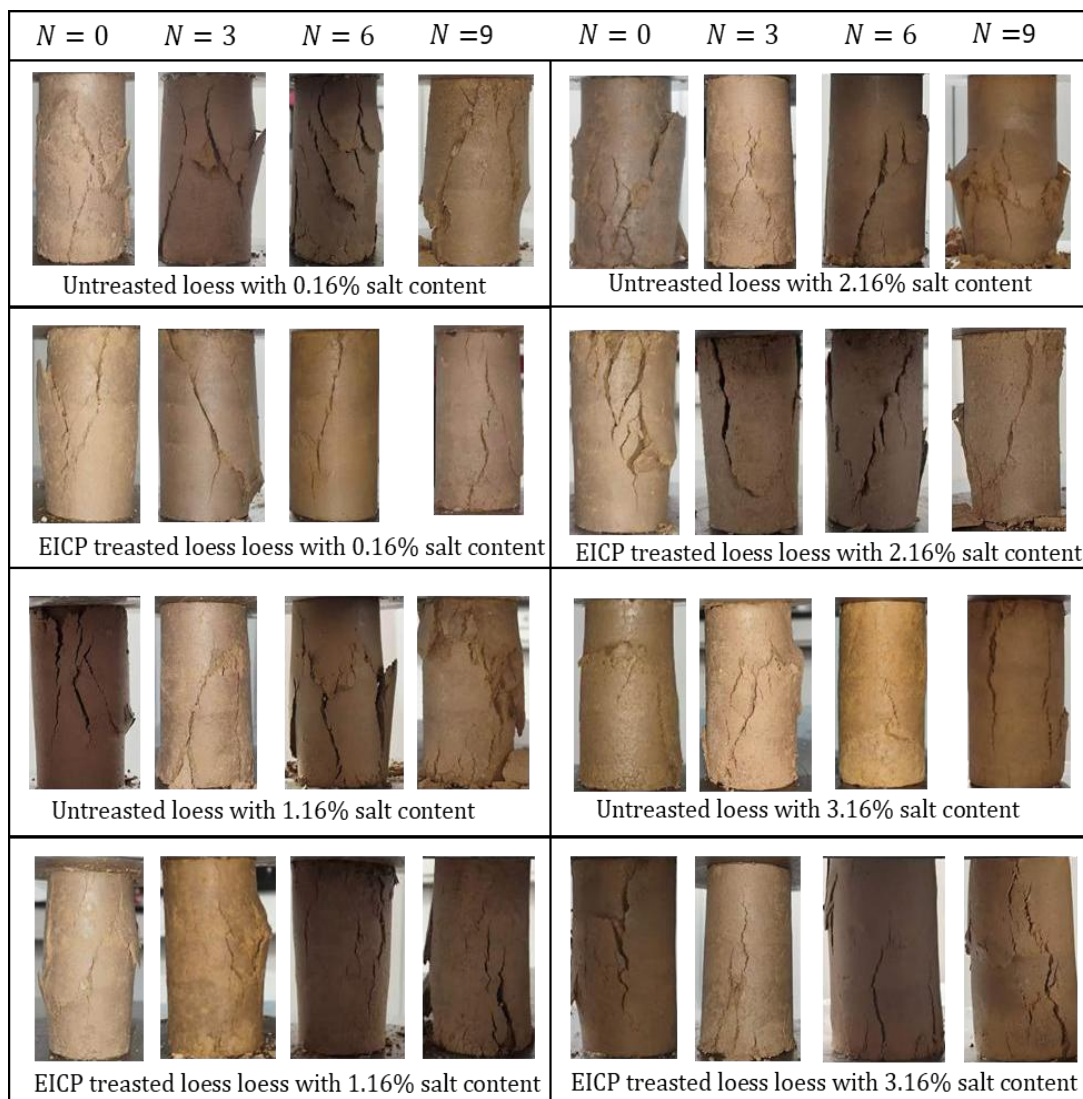
Figure 8 – Failure modes of molded loess specimens after freeze-thaw cycling under UCS testing

Under unconfined compression, soils typically exhibit several characteristic failure modes, including end shearing, barreling, single shear plane, and disintegration. Figure 8 presents the failure patterns of loess specimens subjected to freeze-thaw cycling under unconfined compressive conditions. The results indicate that, with increasing numbers of freeze-thaw cycles, the failure mode progressively evolves from end-dominated shear and distinct single shear planes to distributed cracking, and ultimately to disintegration.

An increase in salinity further accelerates this transition by weakening interparticle bonding and inducing crystallization-related damage. Under the combined effects of numerous freeze-thaw cycles and elevated salinity, the specimens exhibit pronounced structural collapse and fragmentation, reflecting a shift from shear-controlled failure to degradation governed by structural deterioration.

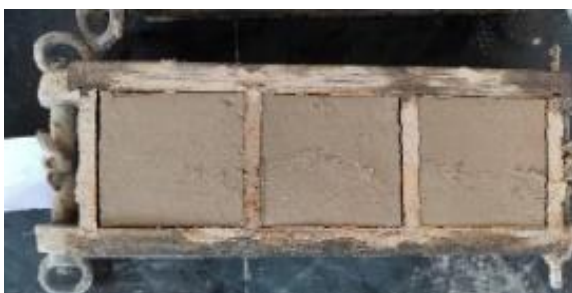
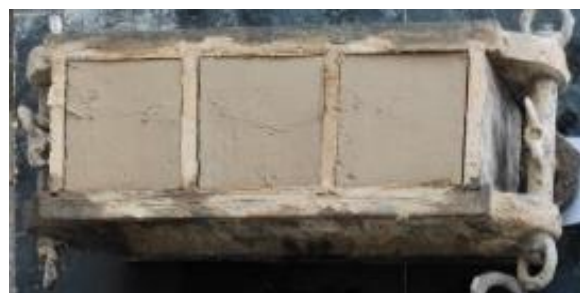
a) Gap appearing between the specimen and the mold

b) Micro-cracks appearing on the surface of the specimen

The phenomenon of volumetric shrinkage occurring during the setting process of earthen mortar, also referred to as drying shrinkage, is illustrated in Figure 3.
