# Technobius

## Volume 6, No. 2, 2026

*Special Issue on Advances in Civil Engineering Materials and Structures*

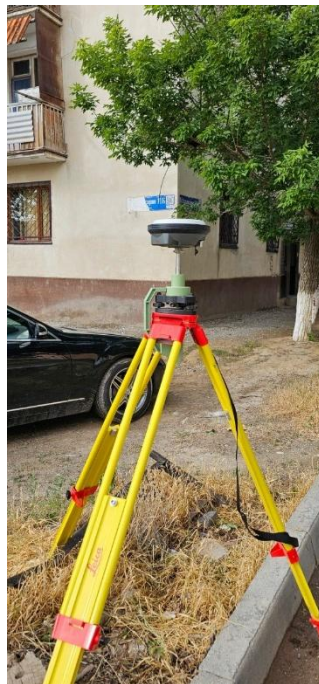
Figure 3 illustrates a typical temporary GNSS benchmark used for network referencing.

Figure 3 – Temporary GNSS benchmark

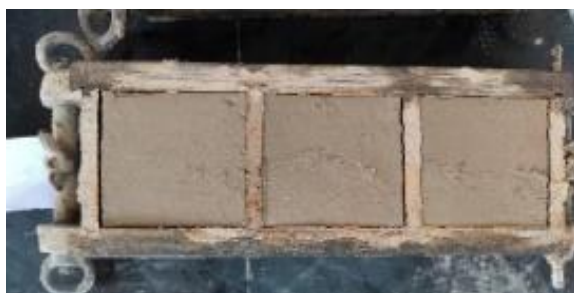
The phenomenon of volumetric shrinkage occurring during the setting process of earthen mortar, also referred to as drying shrinkage, is illustrated in Figure 3.

a) Gap appearing between the specimen and the mold

b) Micro-cracks appearing on the surface of the specimen

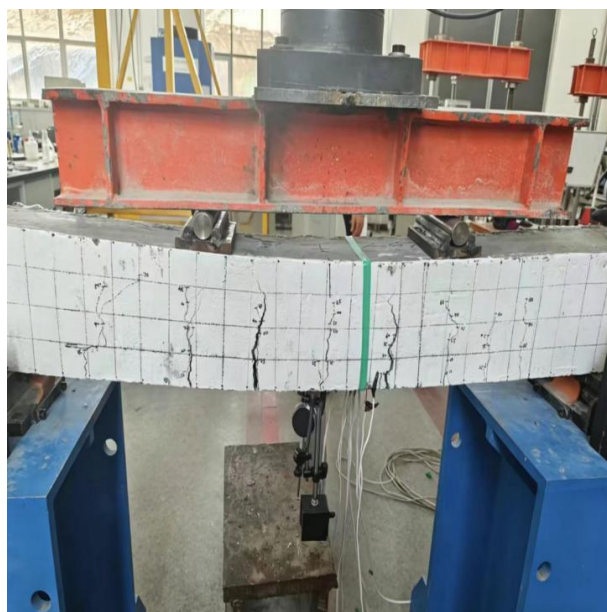
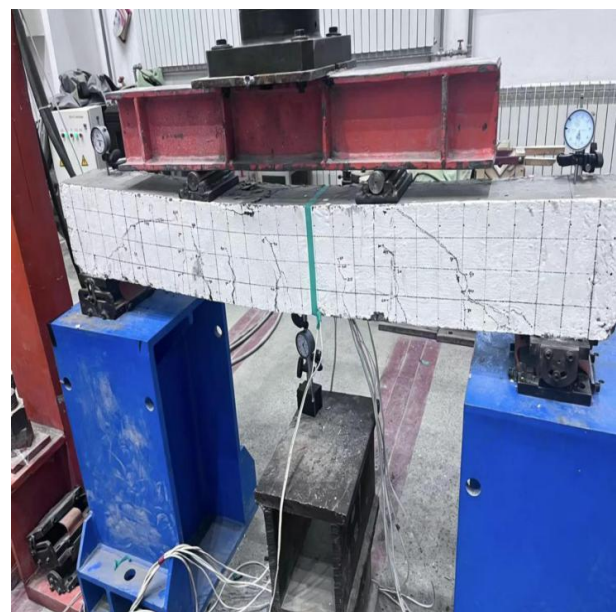
The experimental results show clear differences between the flexural and shear responses of the reinforced concrete beams. Although both specimens were tested under vertical loading, their crack development, load-displacement behavior, reinforcement strain response, and failure mechanisms were substantially different. The flexural beam exhibited a ductile failure mode governed mainly by tensile reinforcement yielding and subsequent concrete crushing, whereas the shear beam showed a more sudden and brittle failure mode controlled by diagonal cracking in the shear span. The observed failure patterns are presented in Figure 3.

a) Flexural failure

b) Shear failure
