Technobius, 2025, 5(1), 0072, DOI: https://doi.org/10.54355/tbus/5.1.2025.0072

Rehabilitation of lengthy sewer pipelines by polymer-composite CIPP

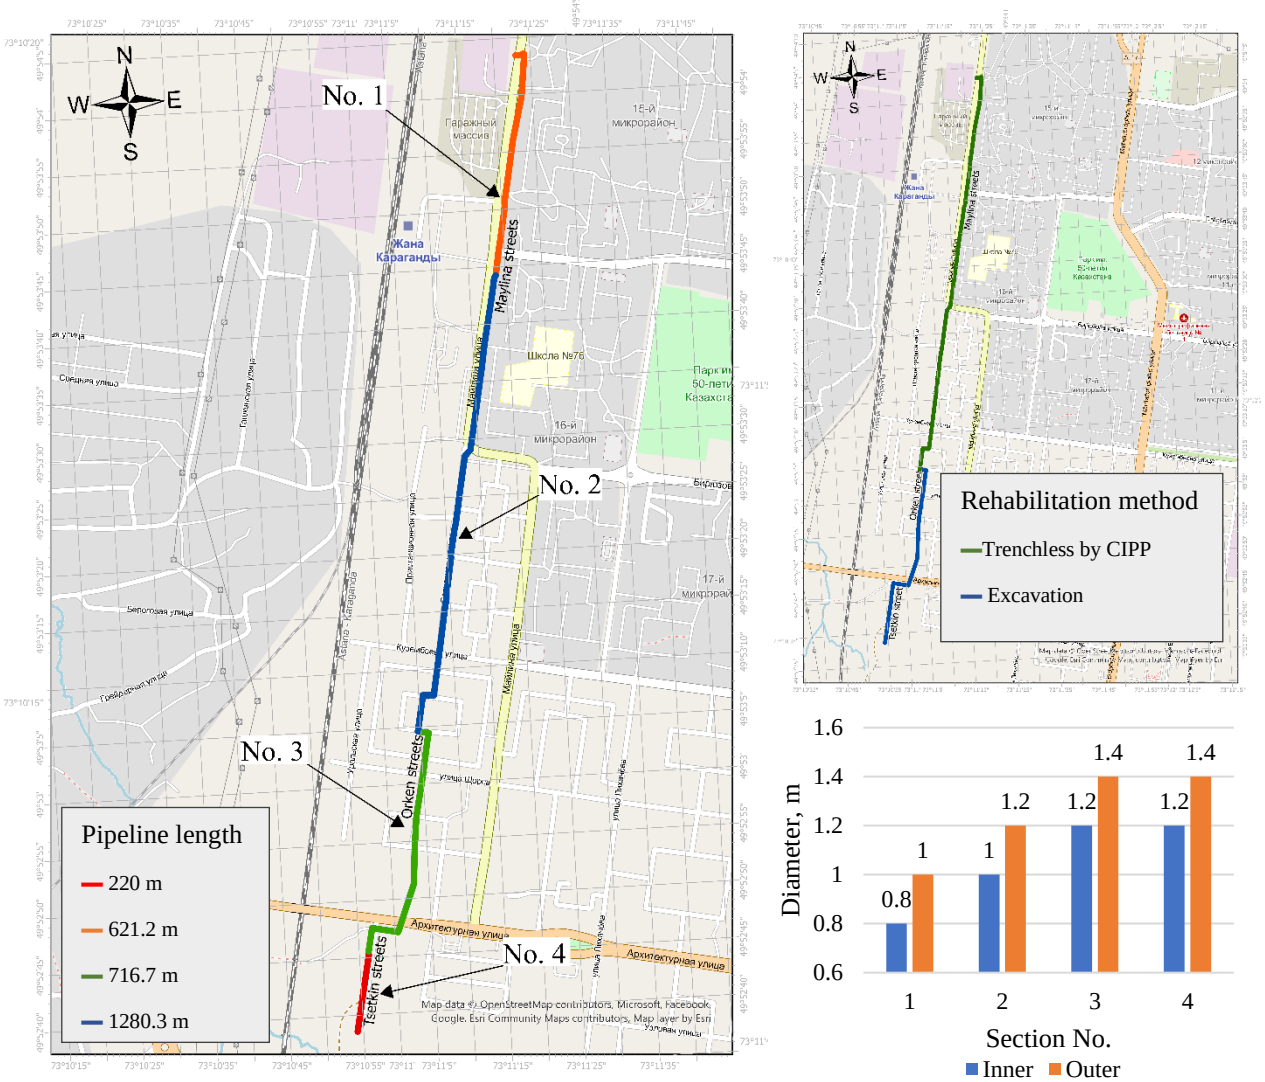
Figure 2 – Map of pipeline rehabilitation

Figure 2 above shows a rehabilitation map of pipelines, which are split into 4 sections and colored differently, with lengths of 621.2, 1280.3, 716.7, and 220.0 meters, respectively, altogether amounting to 2838.2 m, including 2618.2 m rehabilitated with the trenchless CIPP, and 220 m with the excavation method. It also shows the inner and outer diameters of the pipes, which range from 0.8 to 1.2 m for the inner diameter, and from 1.0 to 1.4 for the outer diameter.

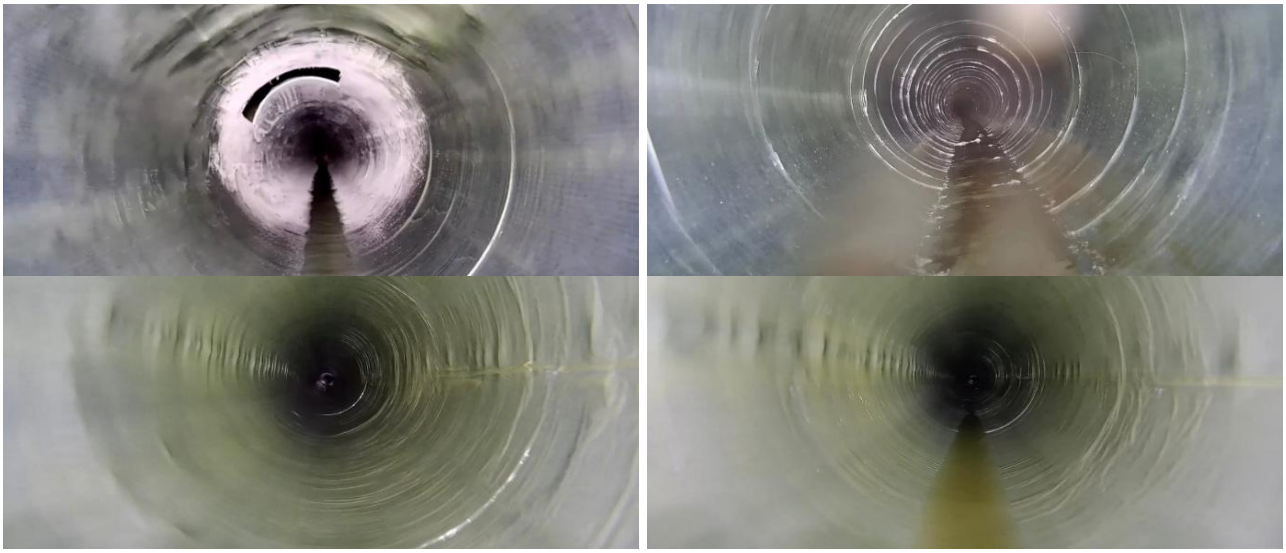
Figure 3 – Pipelines condition after CIPP installation

Figure 3 above clearly demonstrates how much the pipes were transformed after the cleaning, washing, and installation of CIPPs. It is possible to observe an increase in diameter, and consequently

stabilization of sewage flow. The post-installation CCTV images clearly show a significant improvement in the structural condition of the pipelines. The previously observed cracks, joint misalignments, and obstructions were eliminated after the cleaning and CIPP installation. The increase in pipeline smoothness is expected to enhance sewage flow and reduce the likelihood of further debris accumulation.

Figure 3 shows the reshoot images of CCTV representing the CIPP installation results after the careful treatment (cleaning and washing) of existing pipelines.

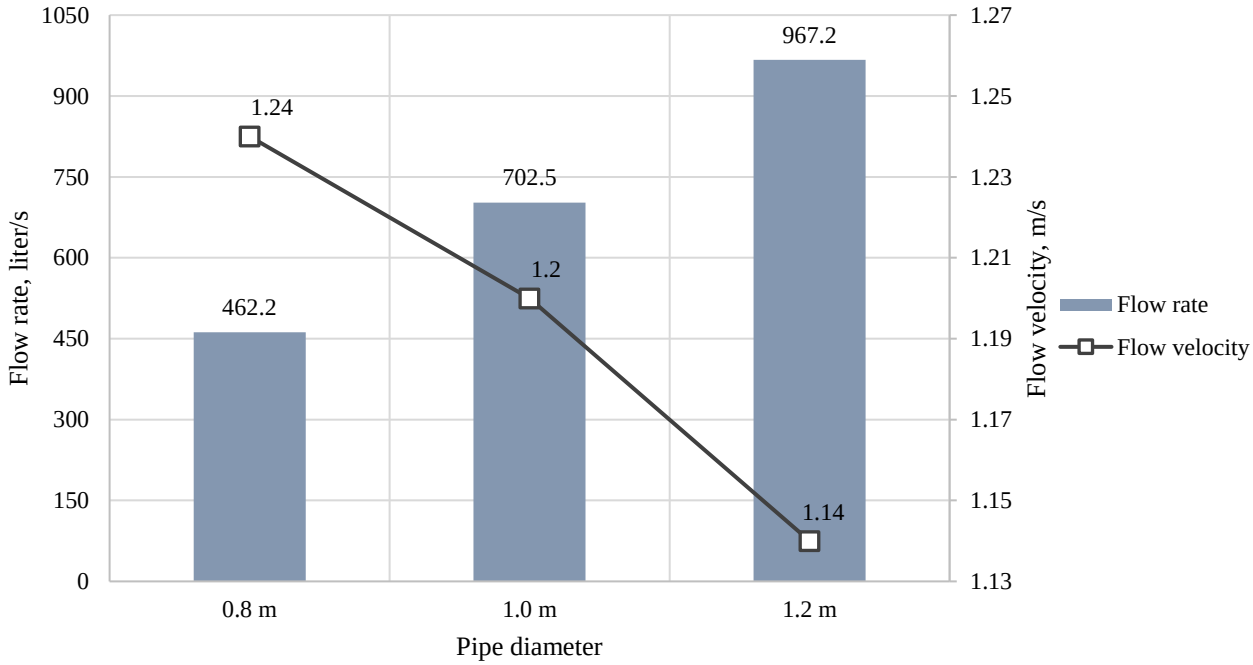
Figure 4 – Results of flow rate estimates

According to Figure 4 above, for a 0.8 m diameter pipe, the flow rate is 462.2 liter/s with a velocity of 1.24 m/s, for 1.0 m – 702.5 liter/s at 1.2 m/s, and 1.2 m – 967.2 liter/s at 1.14 m/s (710 liter/s and 1.2 m/s in average). A clear trend is observed: as the pipe diameter increases, the water flow rate rises, while the flow velocity decreases. This is explained by the fact that a larger diameter increases the cross-sectional area of the pipe, allowing a greater volume of water to pass through while simultaneously reducing the flow velocity under the same hydraulic conditions. These results suggest that the rehabilitated pipelines are better suited to handle peak flow conditions, minimizing risks of overflows and blockages.
