Rehabilitation of lengthy sewer pipelines by polymer-composite CIPP

Abstract. This study examines the feasibility of Cured-in-Place Pipe (CIPP) technology for trenchless rehabilitation of aging sewer pipelines, addressing the severe deterioration of Karaganda's sewer networks. A 3 km section was inspected using CCTV, ultrasonic, and shock-pulse methods to assess pipeline conditions, revealing structural defects with depreciation levels reaching 70-100%. The CIPP method was successfully applied to restore the integrity of 2.6 km pipelines while minimizing excavation, stabilizing the average flow rates and velocity of 0.8-1.2 m pipelines at 710 liter/s and 1.2 m/s, respectively. Hydraulic analysis confirmed that rehabilitated pipelines maintained sufficient flow velocity for self-cleaning and increased capacity, reducing blockage risks. The findings demonstrate that CIPP is a sustainable alternative to pipeline replacement, offering a viable solution for long-length sewer rehabilitation and supporting strategic urban infrastructure renewal.

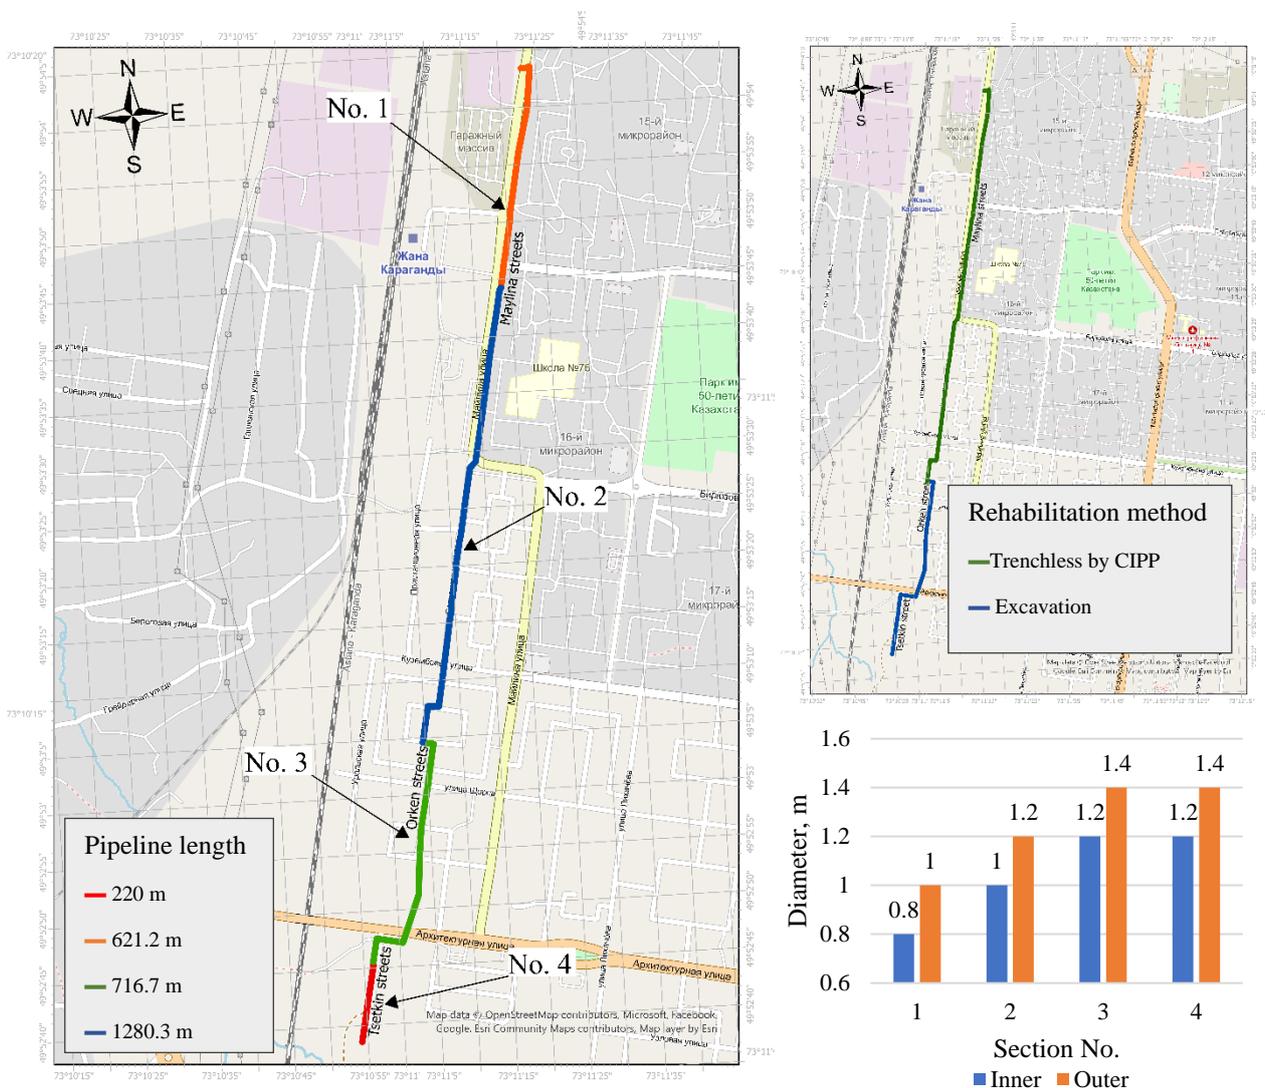
Figure 2 – Map of pipeline rehabilitation

Figure 2 above shows a rehabilitation map of pipelines, which are split into 4 sections and colored differently, with lengths of 621.2, 1280.3, 716.7, and 220.0 meters, respectively, altogether amounting to 2838.2 m, including 2618.2 m rehabilitated with the trenchless CIPP, and 220 m with the excavation method. It also shows the inner and outer diameters of the pipes, which range from 0.8 to 1.2 m for the inner diameter, and from 1.0 to 1.4 for the outer diameter.

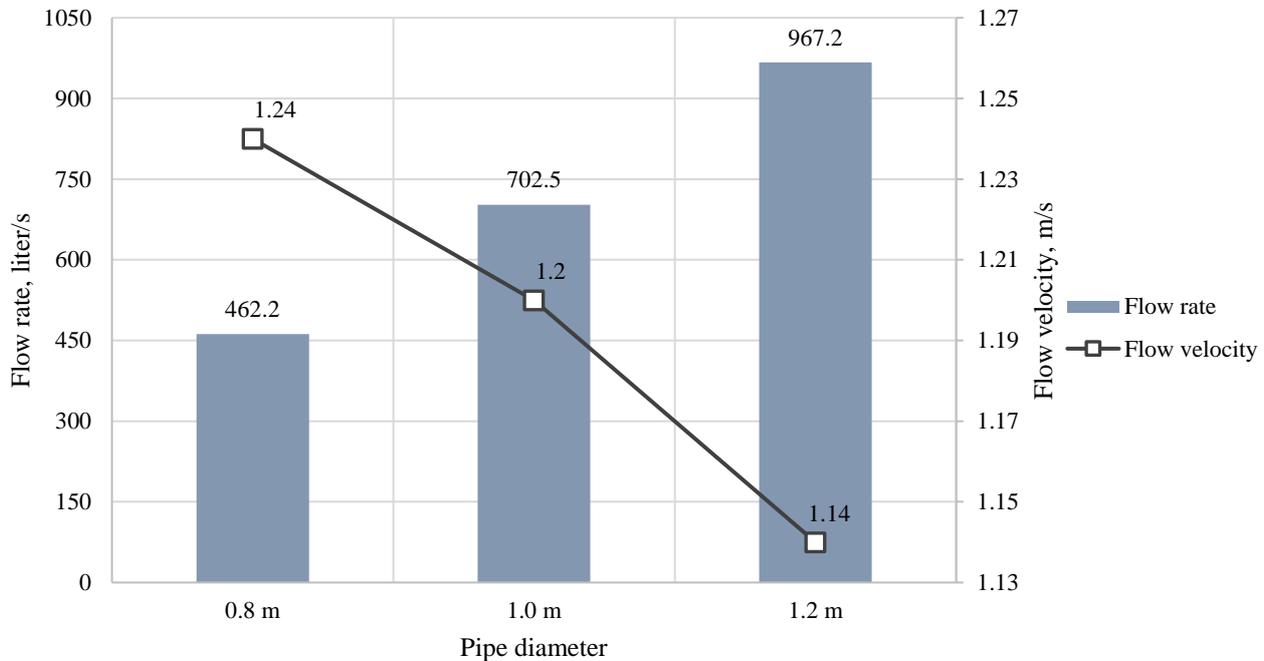
Figure 4 – Results of flow rate estimates

According to Figure 4 above, for a 0.8 m diameter pipe, the flow rate is 462.2 liter/s with a velocity of 1.24 m/s, for 1.0 m – 702.5 liter/s at 1.2 m/s, and 1.2 m – 967.2 liter/s at 1.14 m/s (710 liter/s and 1.2 m/s in average). A clear trend is observed: as the pipe diameter increases, the water flow rate rises, while the flow velocity decreases. This is explained by the fact that a larger diameter increases the cross-sectional area of the pipe, allowing a greater volume of water to pass through while simultaneously reducing the flow velocity under the same hydraulic conditions. These results suggest that the rehabilitated pipelines are better suited to handle peak flow conditions, minimizing risks of overflows and blockages.
